PRACTICAL STEPS TO MAXIMISE THE VALUE OF YOUR CONCRETE PIPE ASSETS

Andrew DuFresne (AWT New Zealand)

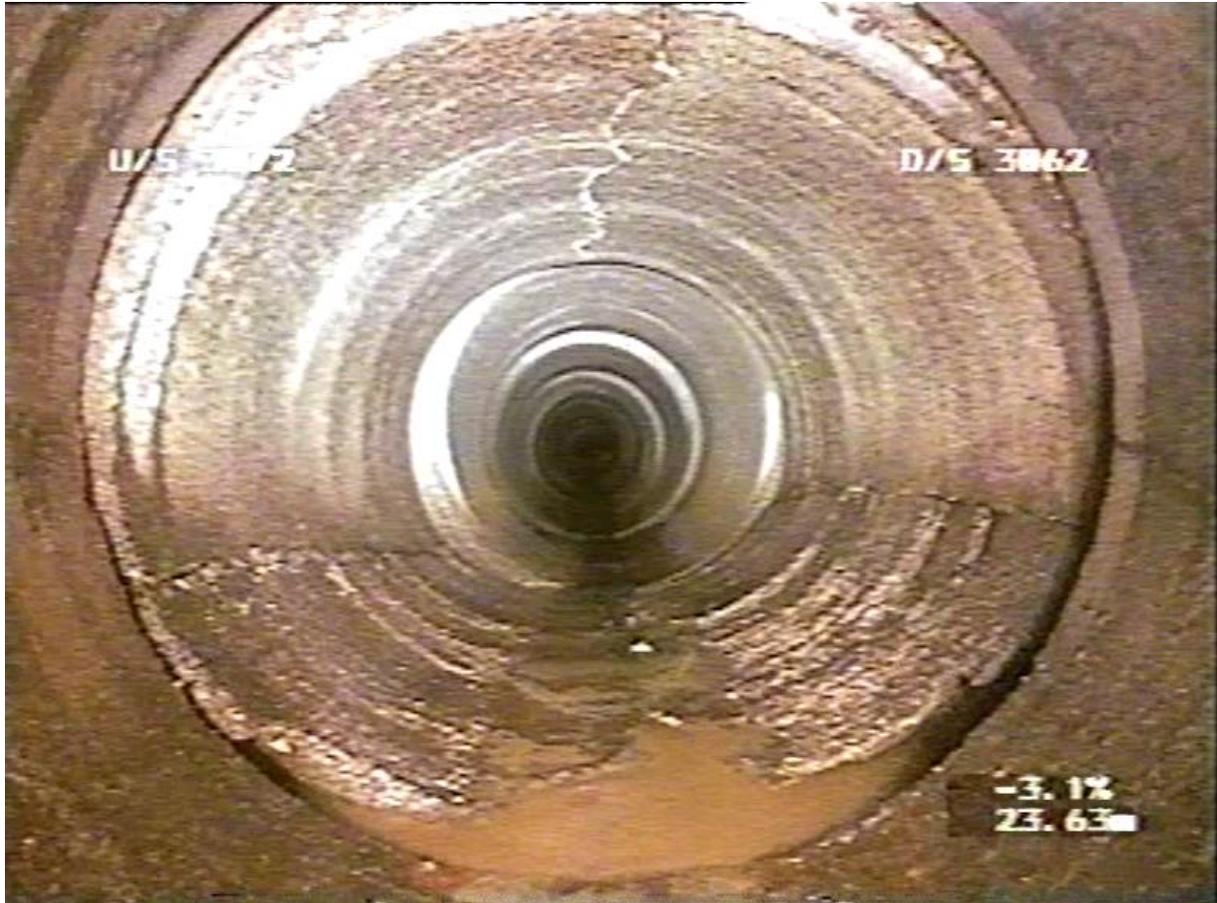
Some TLA's have reported a tendency for older precast pipes to catastrophically fail with little or no warning. In this photograph you can see a typical older precast concrete pipe in severely deteriorated condition. Longitudinal cracking indicates overloading and possibly imminent catastrophic failure. Note how the invert is seriously eroded, which indicates poor quality concrete. There could also have been an upstream discharge of acid, but in this case it was regarded as unlikely.

The reason I have brought up the subject of precast pipes is that they are sometimes mistaken for spun concrete. In general it is good practice to line or replace precast pipes.

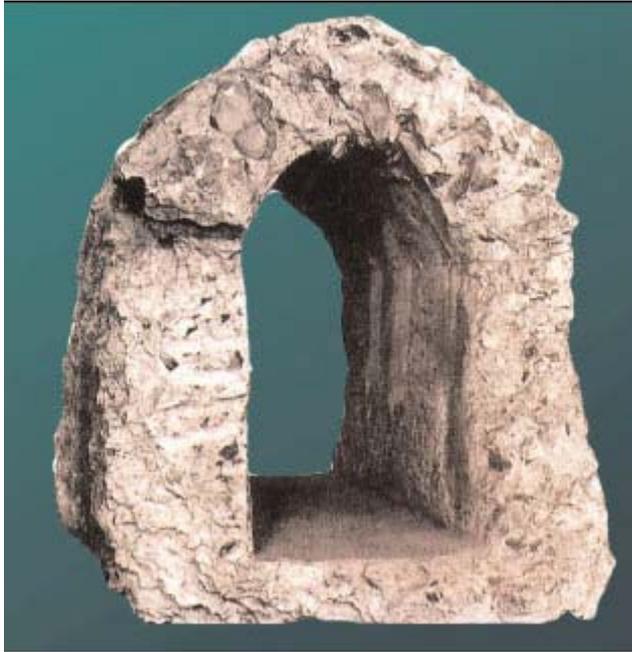
On the other hand spun concrete pipes are made to a very high standard and should last in the ground a very long time. There is a common misconception that the life span of a pipeline is about 80 years. However we all know this is a gross simplification. The pipeline in the previous photo was probably good for about 40 years. The following photograph shows a section of concrete conduit built by the Romans. Some of these are still in use.

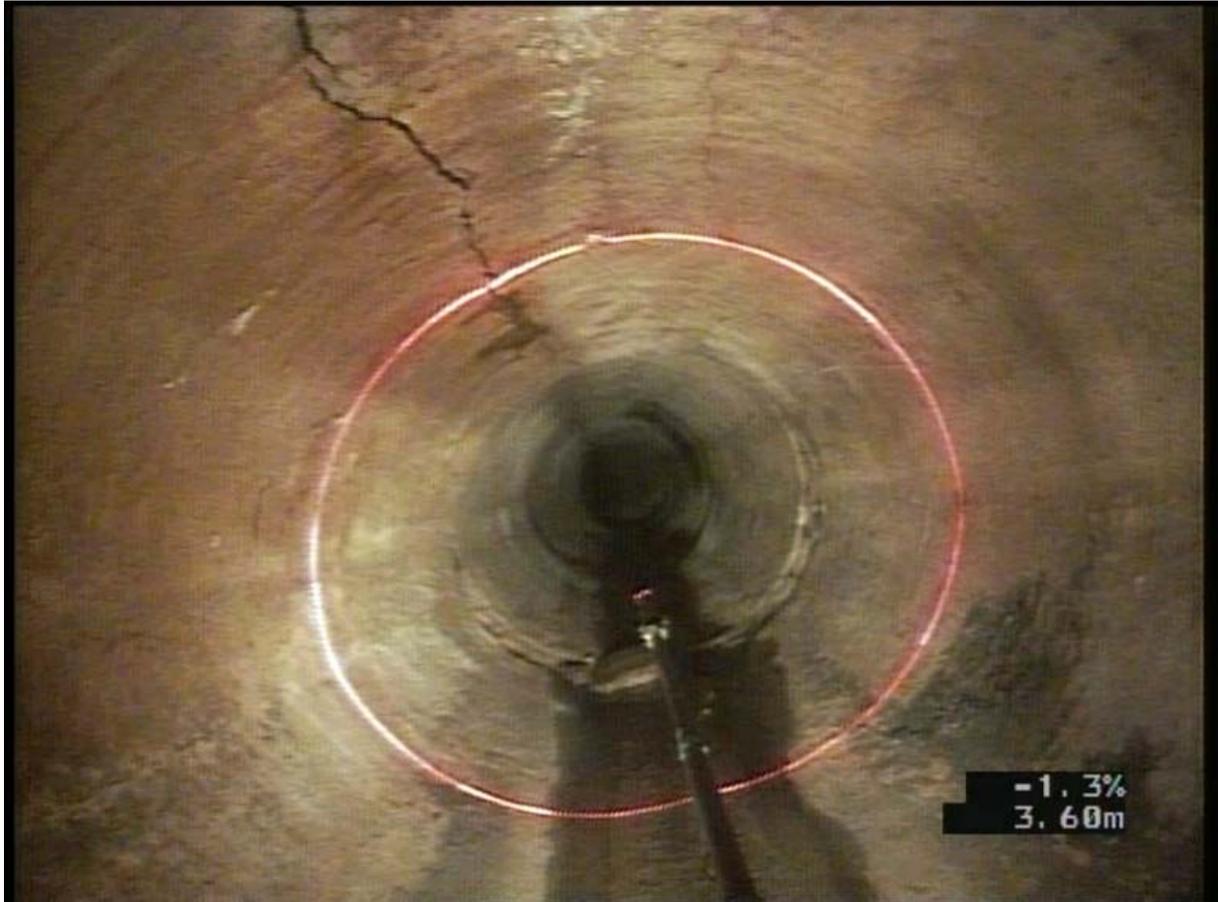
Longitudinal cracks are recorded as CL on the logsheets. Longitudinal cracks in concrete pipes at the quadrant points (3, 6, 9 and 12 o'clock) are indicative of over-stressing and can be a precursor of severe pipe deformation (DF) or even total collapse. The following photograph shows a severely overstressed spun concrete pipe.

This photograph was taken during laser profiling of a concrete stormwater about 1500mm diameter. The laser light provides an indication of the extent of the deformation of the pipeline.

There is a large longitudinal crack in the soffit at 12 o'clock which confirms the pipe has been severely overstressed. The ovality of this pipeline was measured at 9.6% at this point. At this stage it is thought that the overstressing was caused by major earthworks over the pipe. (I would like to point out that the actual laser profiling is carried out with the CCTV camera lights switched off, and the calculations for determining ovality are made with dedicated software off-site.)

A brief explanation of laser profiling. This is a new pipeline assessment tool which was developed by a New Zealand company in Albany in North Shore City. A laser light attached to a CCTV camera generates a ring of light which reflects off the pipeline interior wall. A computer programme analyses the difference between the laser light and a pre-set pipe base shape which can take practically any form, including box culverts, egg-shape culverts and circular pipes. The difference between the base shape and the actual interior wall can be measured to within 2-3mm. For a circular pipe its ovality is automatically calculated in accordance with the standard ASTM F1216.

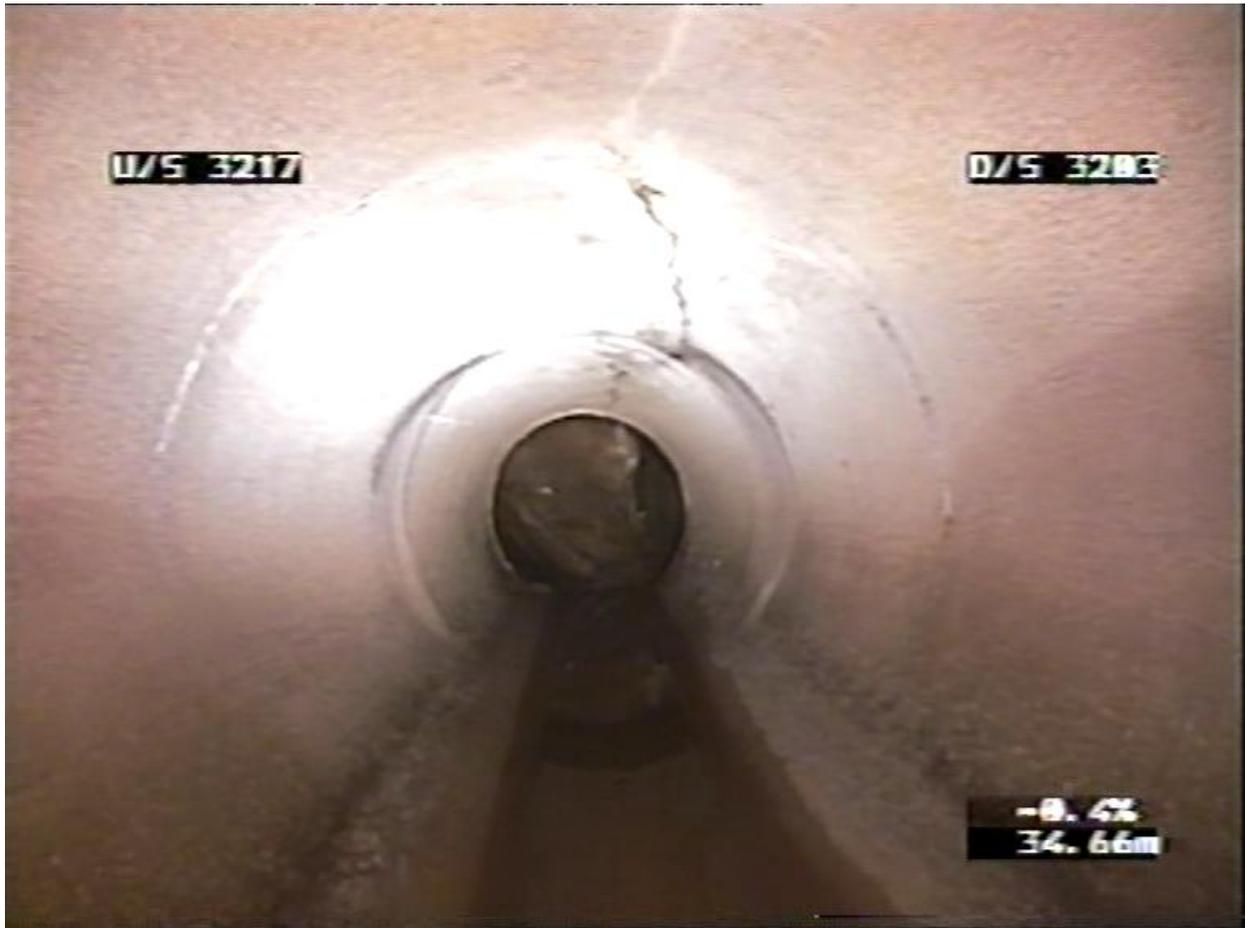
The following damage was noted in a 525mm stormwater pipe. Laser profiling was not involved in this case.

This pipe was well within design depth and had no superimposed load. It is assumed that the crack at 12 o'clock and the apparent deformation was caused by temporary earthmoving loads.

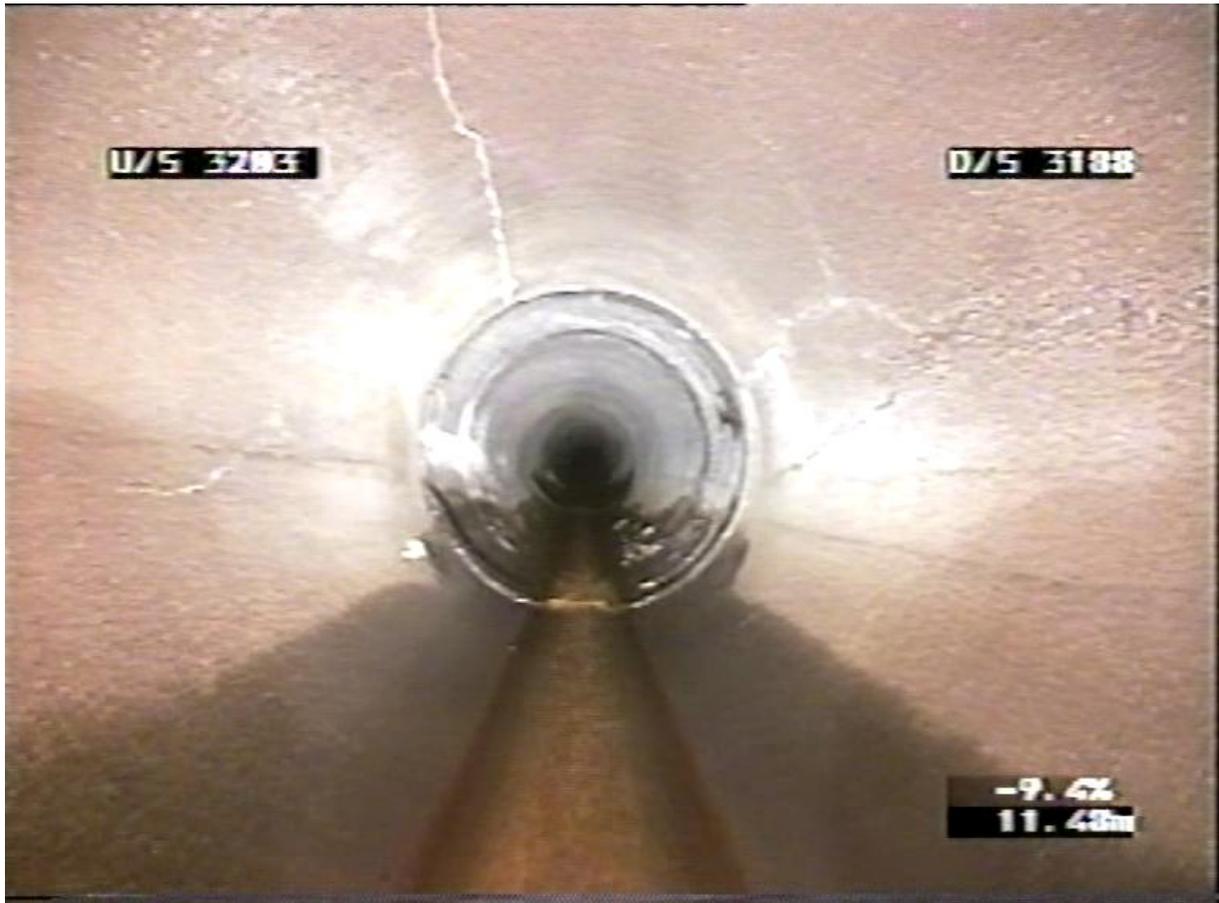
In both the following photographs cracking in spun concrete pipes has autogenously healed. In other words the concrete has cracked due to tensile stresses imposed on it, and then the reinforcing has taken up the stresses. Changes to the chemical composition of the concrete in the cracking zone have created a matrix of calcium carbonate crystals, which effectively seal the cracks. In the first photograph the autogenous healing shows up as a white deposit in the cracking.

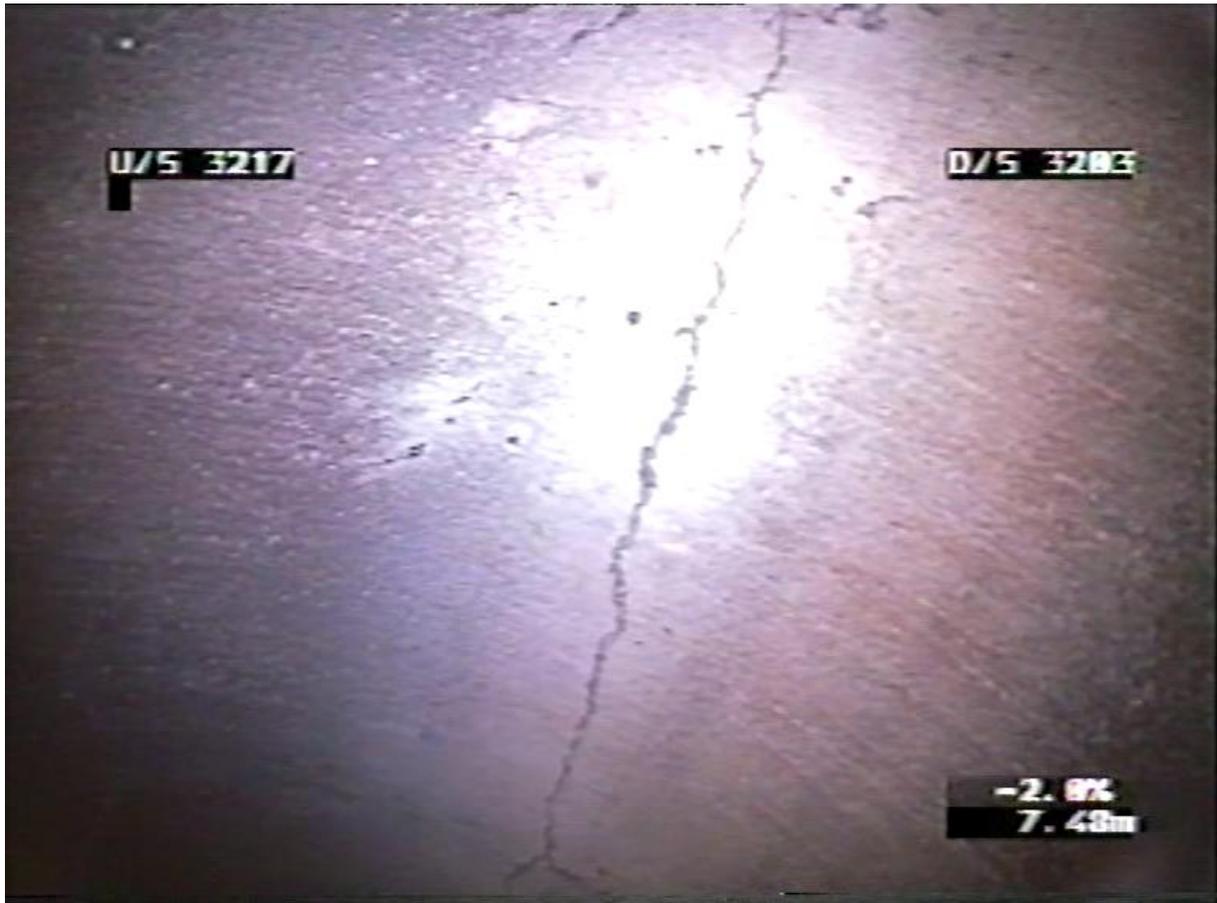
In the second photograph the cracking is a little wider but appears to have autogenously healed. A prudent engineer would confirm this scenario.

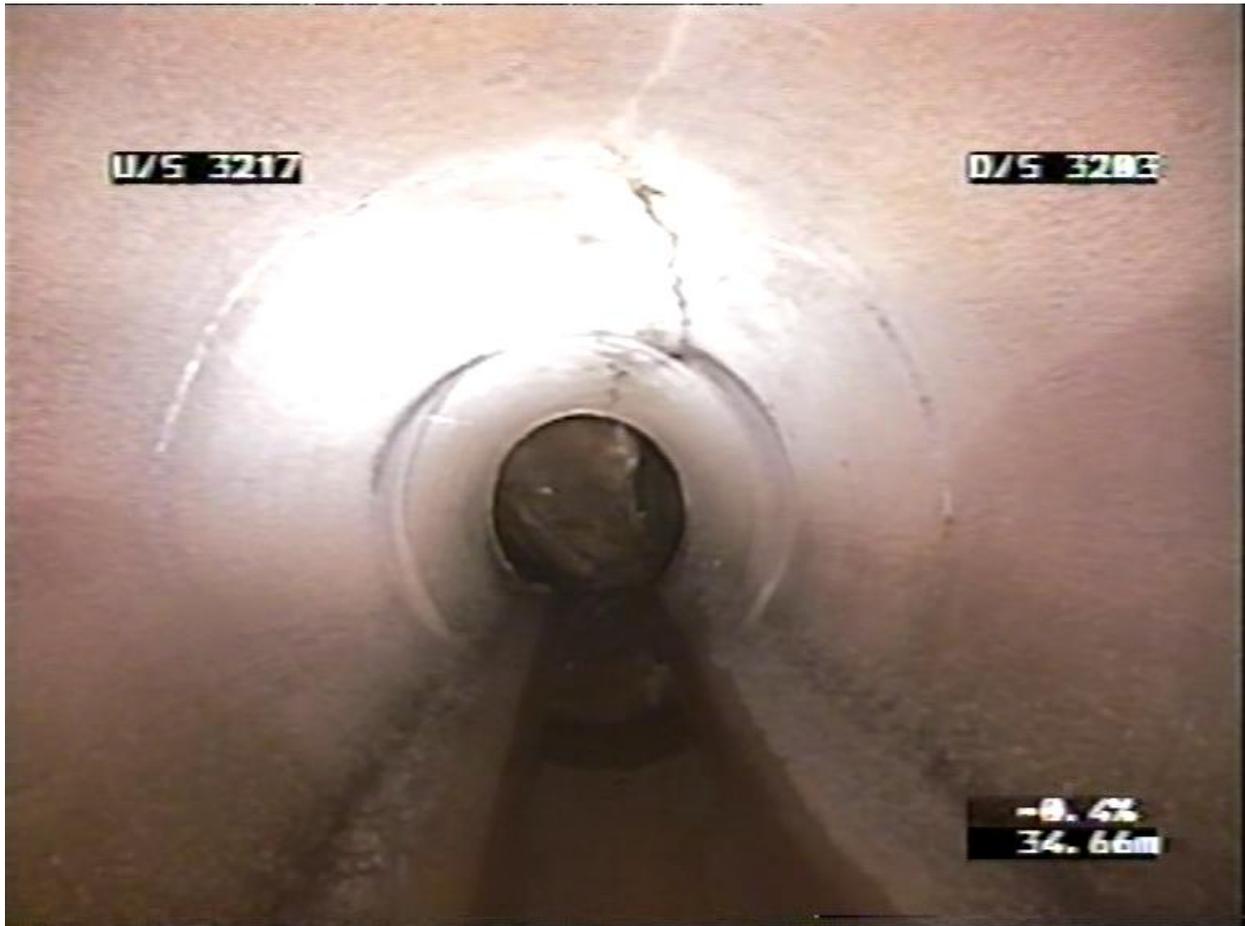
In the Papakura stormwater assessment project, some pipes showing significant cracking, and even ovality, had very little cover and it was concluded that temporary overloading may have been responsible.

An Australian investigation into temporary construction loads on buried pipelines found that earthmoving and compaction equipment was capable of exerting a force on the ground of up to double a standard (Australian) wheel load of 7 tonnes in a W-7 configuration, and would typically be applied during backfilling, at depth of cover far less than design cover. This research underlies the necessity for not only allowing for temporary loads in design calculations, but more importantly for leaving the acceptance CCTV inspection of new (and existing) buried pipeline assets until all earthworks and road sealing, in the vicinity, is completed.
