Concrete stormwater drainage pipelines - acceptance using CCTV inspection

Patrick V McGuire, *Executive Director, Concrete Pipe Association of Australasia*
Dr Norwood Harrison, *Technical Support Manager, Humes*

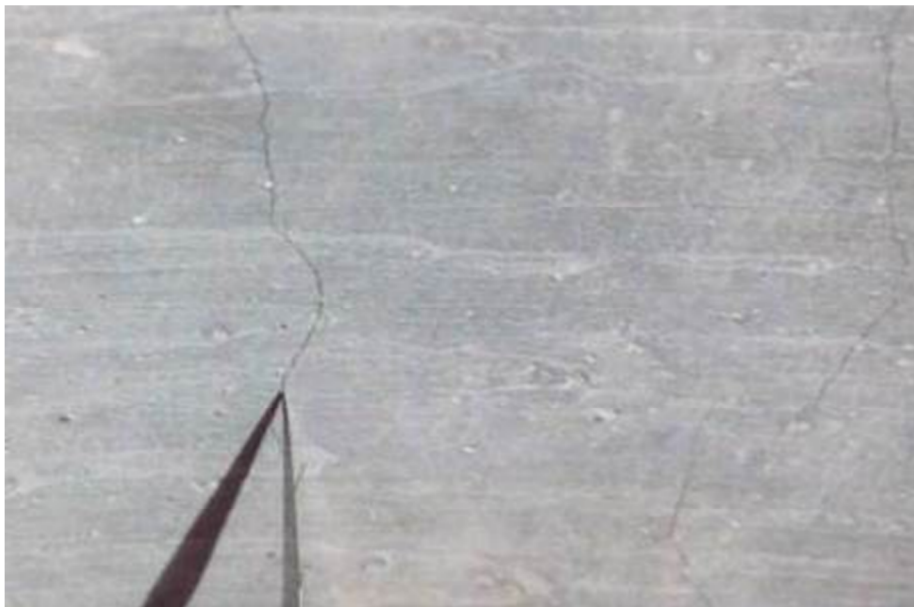
Cracks in concrete pipe under test for proof load. Feeler gauge is used to test crack width.

The proof load test adopts procedures from previous Australian and New Zealand Standards for concrete pipe, which in turn follow American (ASTM) practice developed in the 1930s for a limiting crack width of 0.01 inch (0.25 mm) with 1 inch (25 mm) of concrete cover. This particular crack width was arbitrarily proposed by Professor W J Schlick of Iowa State University “because a leaf gauge of that dimension was readily available”³.

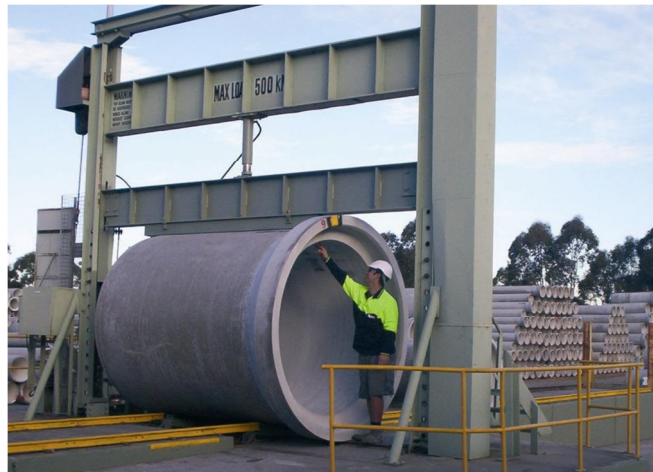
Load testing of Steel Reinforced Concrete Pipe

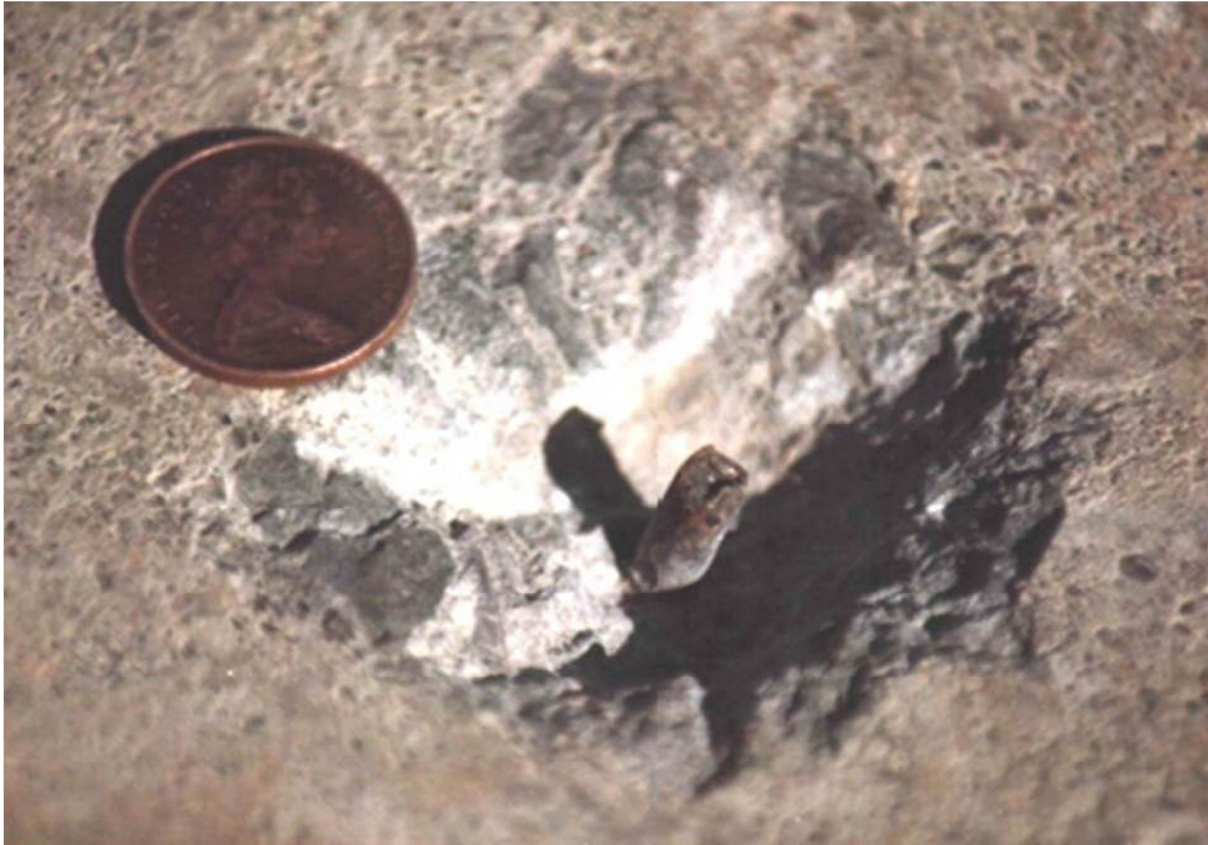
*Figure 4. Reinforcement Spacer – outside surface of pipe
Altona Beach, Victoria, age 32 years. Concrete was chipped away from the spacer, showing negligible corrosion.*

Where these situations have been observed (eg Figs. 4 & 5), surrounding concrete has not been damaged as a result of steel corrosion. This is in contrast to common observations of above-ground structures.

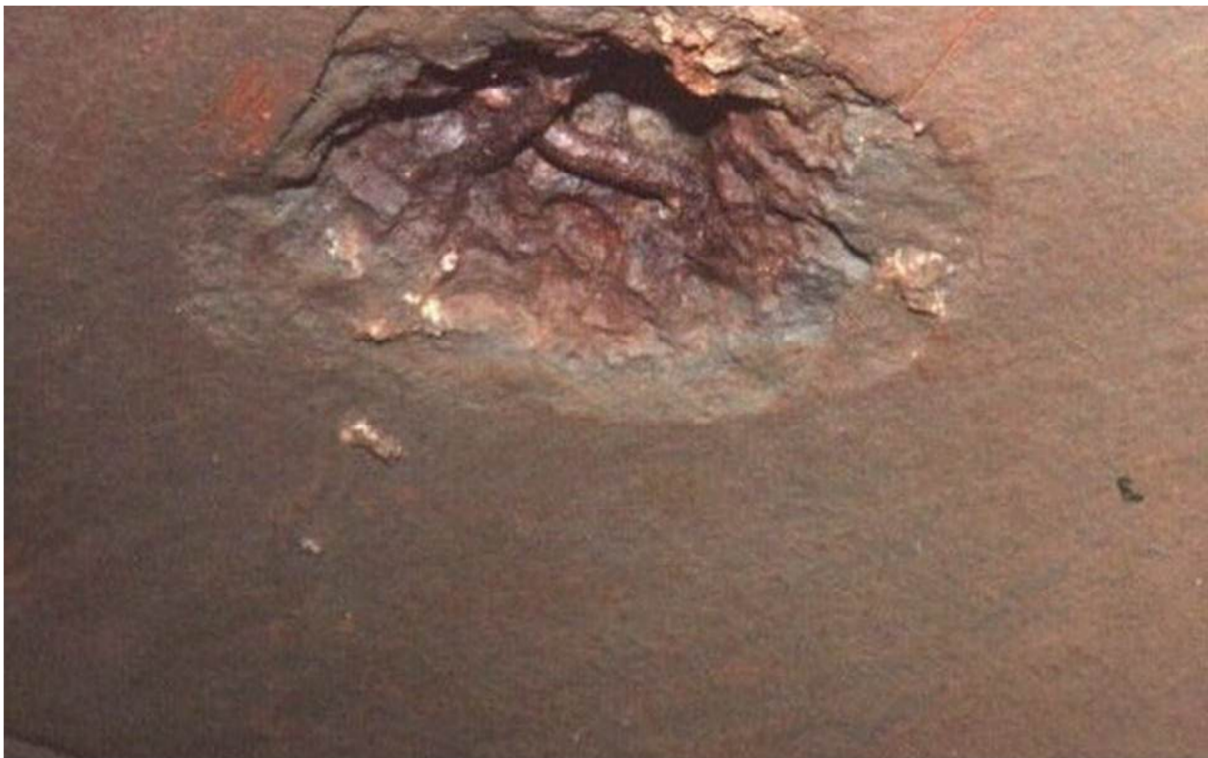
*Figure 5. Exposed steel inside the pipe Hen & Chicken Bay, Drummoyne, NSW; 1500 mm pipeline, age about 30 years.
Inspected as an example of concrete pipelines subject to tidal flow.
Reinforcing steel is exposed at a subsidiary lifting hole knocked through the pipe wall.*
