The Facts About
Cracking in
Steel Reinforced
Concrete Pipes

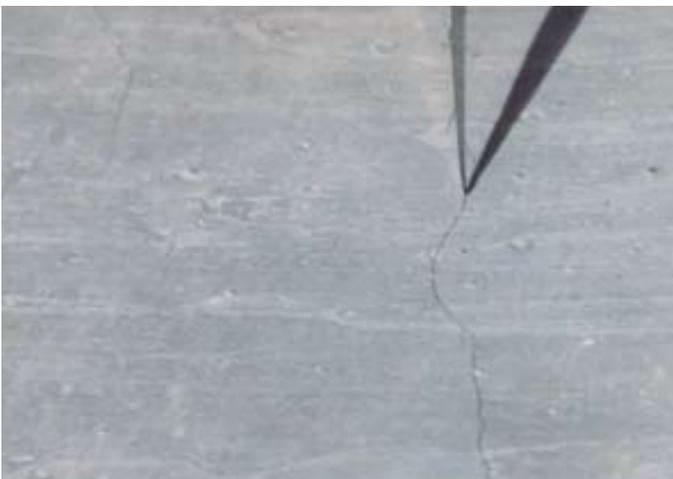
**Cracks in concrete pipe under external load.
Feeler gauge is used to test crack width**

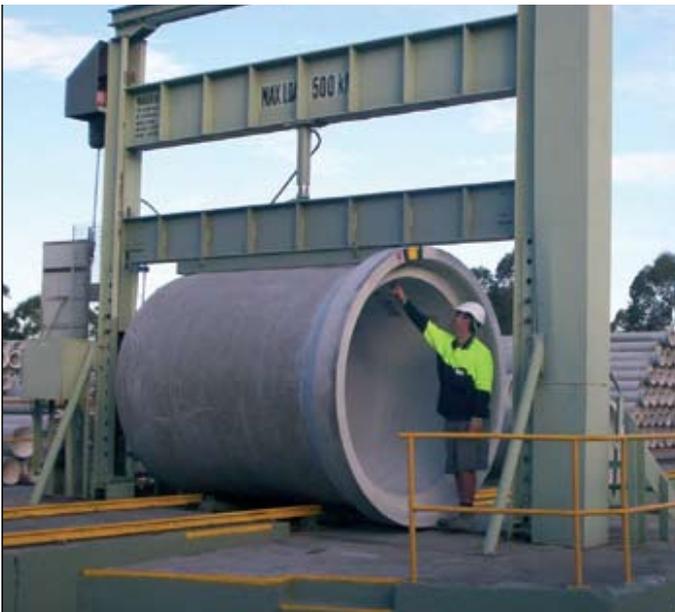
Load testing of Steel Reinforced Concrete Pipe

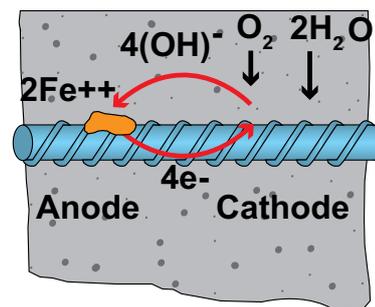
Figure 1

Simplified model of corrosion process

The rate at which corrosion can progress depends on the electrical resistance of the path external to the bar between anode and cathode. This path passes through boundary layers at the steel surface, and the surrounding concrete. The rate also depends on availability of oxygen at the cathode, which is situated in sound concrete – see Figs 1 and 2 (below), reproduced from Ref. 3. Thus the role of the crack is

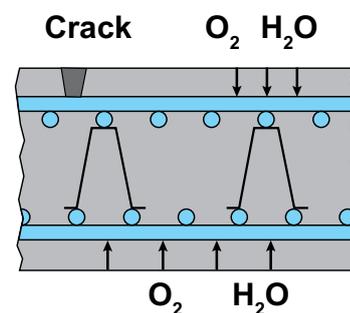
Figure 2

$$\text{Rate of corrosion} = \frac{f(\text{O}_2, \text{H}_2\text{O at Cathode})}{(\text{Resistivity of Concrete})(\text{Size of Cathode})}$$

Factors affecting the rate of corrosion

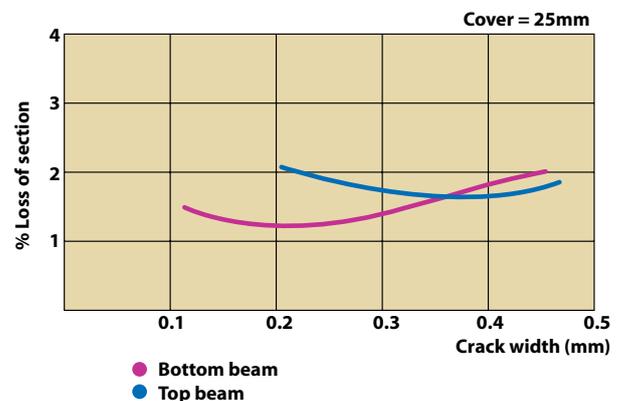
Figure 3

Reinforced concrete in a marine environment - Loss of section of reinforcing bar

to allow the process to be initiated by local loss of passivity but the rate of corrosion depends on the properties of the sound concrete. The Facts about Cracking in Steel Reinforced Concrete Pipe Load testing of Steel Reinforced Concrete Pipe concrete. Results of corrosion tests shown in Fig. 3 (from Ref. 4) confirm that, within the range shown, the crack width has very little effect.

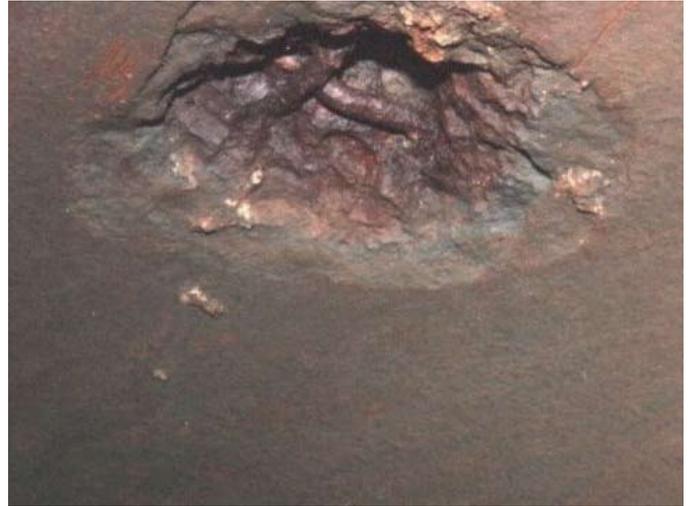
Figure 4 – Concrete pipe with exposed steel

*Hen and Chicken Bay, Drummoyne, NSW.
1500 mm pipeline – age about 30 years.*

Inspected as an example of concrete pipelines subject to tidal flow. Reinforcing steel is exposed at a subsidiary lifting hole knocked through the pipe wall. This situation is assessed as not-deleterious.

- Use of mild steel wire for reinforcement spacers (Ref. 5).
 - Where these situations have been observed (e.g. Fig. 4), surrounding concrete has not been damaged as a result of steel corrosion. This is in contrast to common observations of above-ground structures.

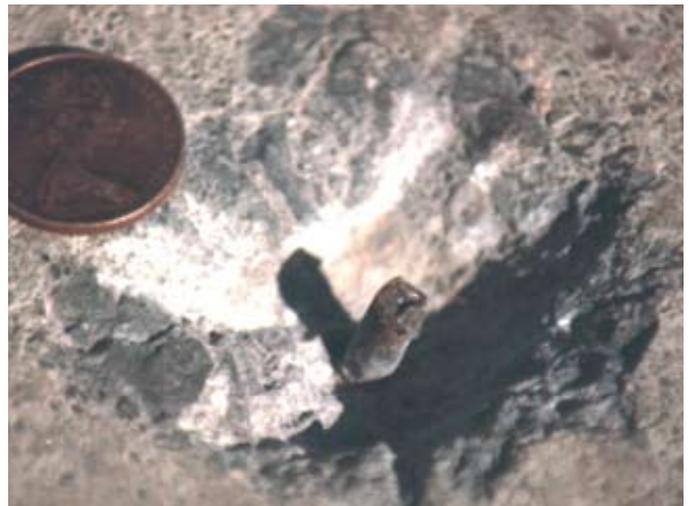
Altona Beach, Victoria - age 32 years.

Example from a survey of mild steel reinforcement spacers. Concrete was chipped away from the spacer, showing negligible corrosion.
