# Autogenous Healing

Concrete Pipe Association  
of Australasia

## Autogenous Healing

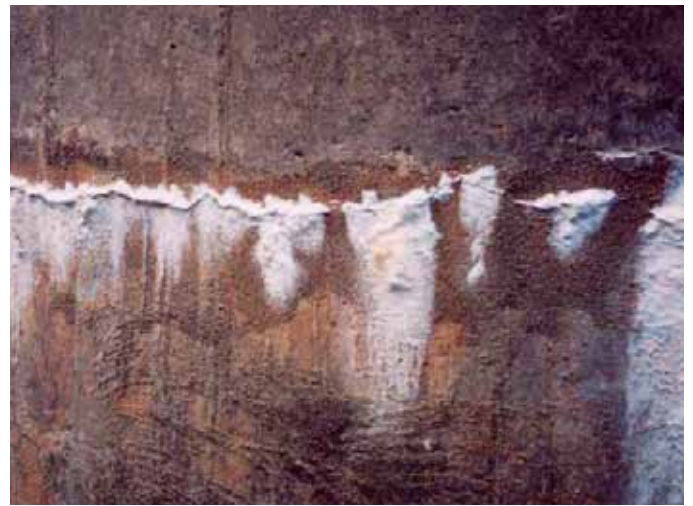
*Autogenous healing at an advanced stage on a water retaining concrete structure.*

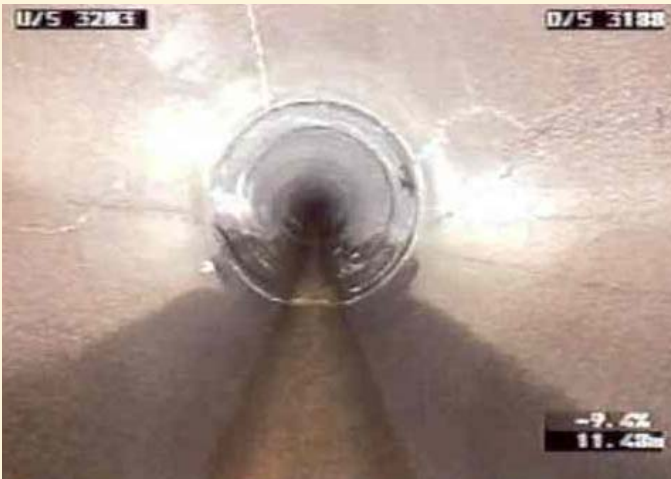
The white line signifies internal autogenous healing in this concrete pipe

Autogenous healing is common in buried reinforced concrete pipe due to the presence of moisture, either on the soil side or inside the pipe itself. These non-moving cracks, when healed autogenously, are impermeable and can yield a structure stronger than the original. One of the reasons is that the concrete pipe seals the crack with calcium-carbonate crystals formed when the carbon dioxide in the surrounding soil, air and water carbonates the free calcium oxide in the cement and the calcium hydroxide liberated by the hydration of the tricalcium silicate of the cement. The formula for this reaction is:

Among examples reported are reinforced concrete pipes that developed shrinkage cracks up to 1.5 mm wide, and were subsequently put into service. Five years later, the cracks were found to be completely closed by autogenous healing.

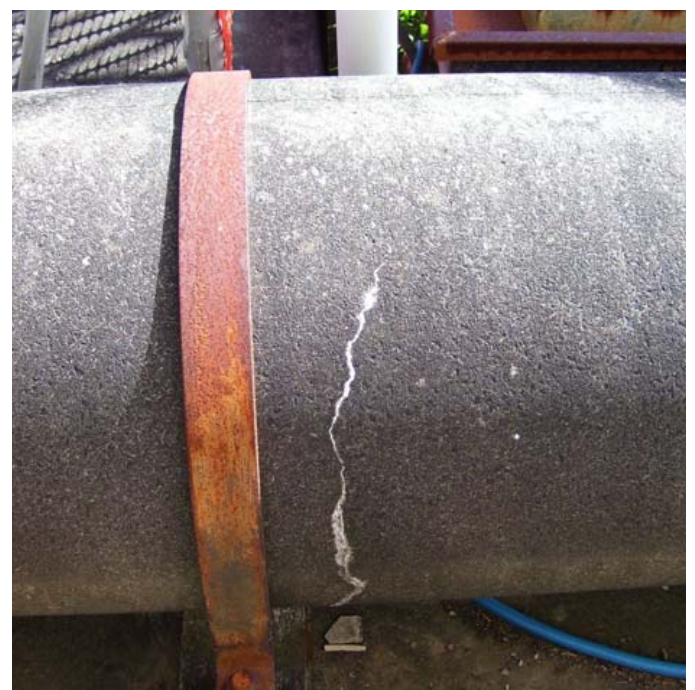
The white line signifies autogenous healing on this exposed concrete pipe
